**Flood Control Project Maintenance
Levee Inspections**

Fall 2014 Levee Maintenance Deficiency Summary Report

Sacramento Maintenance Yard Putah Creek

Waterway			Bank	Unit Miles
Unit No. 01 Putah Creek or North Levee			Left	8.79
	Spring (March - May)	Summer (June - August)	(September - November) Fall	Winter (December - February)
Unit Maintenance Rating (Fall Only)			M	
Date of Inspection	04/14/2014 - 04/14/2014		10/14/2014 - 10/14/2014	
DWR Inspector	Herman Phillips		Herman Phillips	
Accompanied By

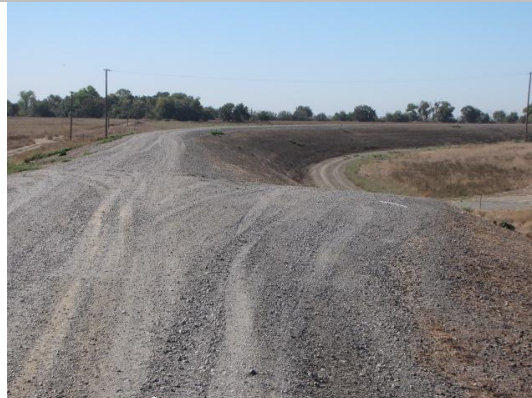
Photo 1 of 1 : FA_2014_ST0007_282_24_20141126_00006.jpg

LM Start	0.00	Rating **	A	Issue No.	24
LM End	8.81	Issue Type +	Ma	Location *	WS
Category	Earthen Levee			GPS Latitude/Longitude	
				Start	End
Item	Vegetation			38.523655 °	38.523893 °
				-121.631435 °	-121.781997 °
DWR ID	DWR_ST0007_01_f_2014_24				
Action/Comments					
Control annual grass and weeds on the levee slopes and easements. Inspector Comments: Slopes well maintained from 0.00 to 8.81.

Putah Creek Unit 1 looking downstream along landside levee slope at levee mile 0.00 to levee mile 8.81.

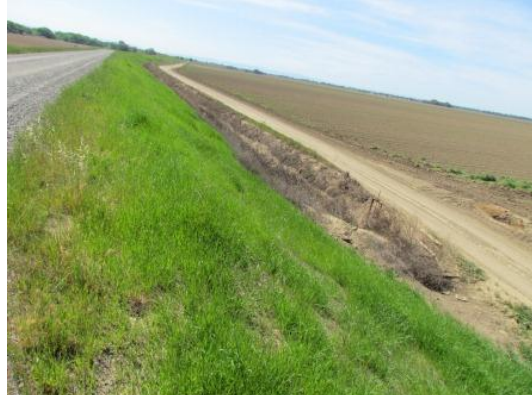
Photo 1 of 1 : FA_2014_ST0007_282_10_20141008_00003.jpg

LM Start	1.51	Rating **	U	Issue No.	10
LM End	2.72	Issue Type +	En	Location *	LS
Category	Earthen Levee			GPS Latitude/Longitude	
				Start	End
Item	Encroachments			38.515322 °	38.517376 °
				-121.654387 °	-121.676054 °
DWR ID	DWR_ST0007_01_s_2012_10				
Action/Comments					
Ditch					
Inspector Comments: This agriculture ditch is owned by Dos Rios Farms. Ending at levee mile 2.72 landside.

Agriculture ditch within 10-foot of levee toe landside. Photo taken 4-14-2014.

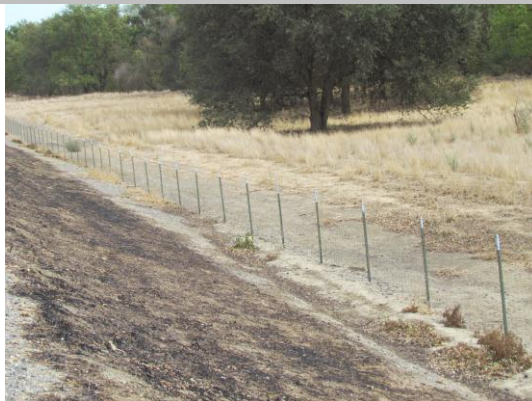
Photo 1 of 1 : FA_2014_ST0007_282_4_20141126_00007.jpg

LM Start	3.31	Rating **	U	Issue No.	4
LM End	3.69	Issue Type +	En	Location *	WS
Category	Earthen Levee			GPS Latitude/Longitude	
				Start	End
Item	Encroachments			38.519831 °	38.520011 °
				-121.686263 °	-121.689552 °
DWR ID	DWR_ST0007_01_s_ 2013_4				
Action/Comments					
Fence Inspector Comments: No permit for this wire fence waterside levee slope.

Wire fence within 10-foot easement waterside levee slope.

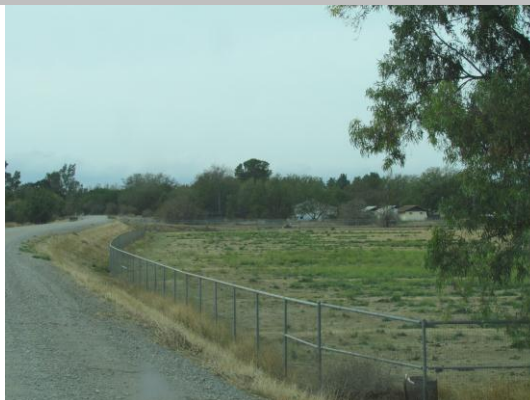
Photo 1 of 1 : FA_2014_ST0007_282_5_20141126_00008.jpg

LM Start	6.76	Rating **	M	Issue No.	5
LM End	6.84	Issue Type +	En	Location *	N/A
Category	Earthen Levee			GPS Latitude/Longitude	
				Start	End
Item	Encroachments			38.517746 °	38.517647 °
				-121.747220 °	-121.748679 °
DWR ID	DWR_ST0007_01_s_2012_5				
Action/Comments					
Fence					
Inspector Comments: This fence has been in the area for many years.					
Levee mile 6.70-6.84 landside within10-foot of easement.

Fence at levee mile 6.76 to 6.84 landside within 10-foot of landward toe.
Not a new encroachment.

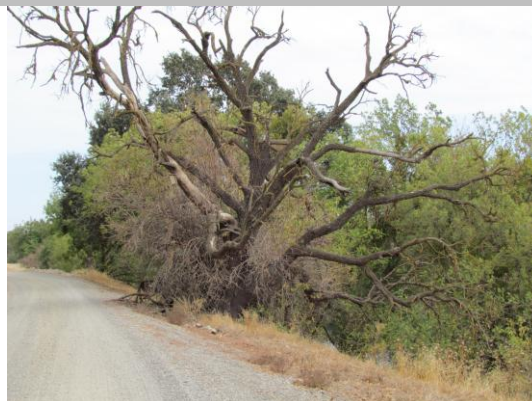
Photo 1 of 1 : FA_2014_ST0007_282_42_20141126_00009.jpg

LM Start	7.02	Rating **	U	Issue No.	42
LM End	7.05	Issue Type +	Ma	Location *	WS
Category	Earthen Levee			GPS Latitude/Longitude	
				Start	End
Item	Vegetation			38.517633 °	38.517586 °
				-121.751856 °	-121.752444 °
DWR ID	DWR_ST0007_01_s_ 2014_42				
Action/Comments					
Trees / Woody Vegetation					
Inspector Comments: This tree needs to be removed before it falls and causes problems to the levee section and or cause injury to pedestrians.

Unit 1 levee mile 7.02 on the waterwardside, a dead tree could cause damage to the levee section.

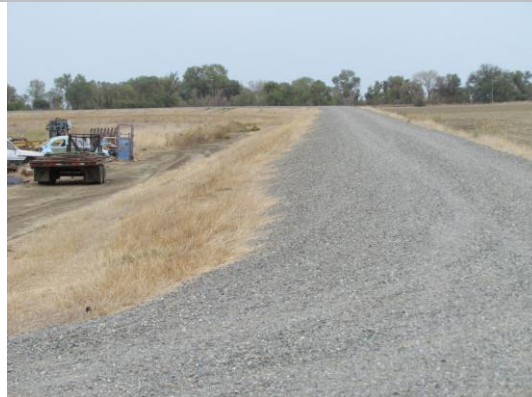
Photo 1 of 1 : FA_2014_ST0007_283_35_20141126_00008.jpg

LM Start	0.00	Rating **	M	Issue No.	35
LM End	7.30	Issue Type +	Ma	Location *	LS
Category	Earthen Levee			GPS Latitude/Longitude	
				Start	End
Item	Vegetation			38.504635 °	38.522693 °
				-121.663179 °	-121.783693 °
DWR ID	DWR_ST0007_02_f_2014_35				
Action/Comments					
Control annual grass and weeds on the levee slopes and easements.

Unit 2 Putah Creek landside levee mile 0.00 looking downstream.

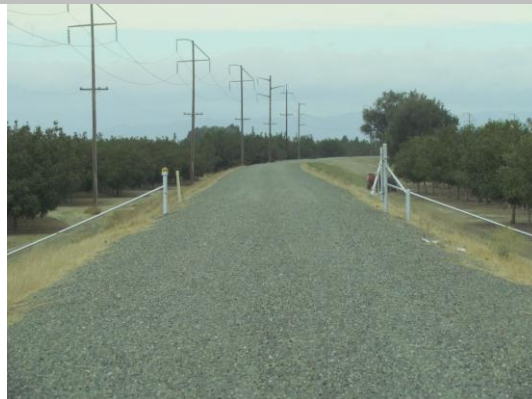
Photo 1 of 1 : FA_2014_ST0007_283_29_20141126_00009.jpg

LM Start	0.55	Rating **	U	Issue No.	29
LM End	0.55	Issue Type +	En	Location *	LS
Category	Earthen Levee			GPS Latitude/Longitude	
				Start	End
Item	Encroachments			38.510249 °	38.510249 °
				-121.667551 °	-121.667551 °
DWR ID	DWR_ST0007_02_s_ 2013_29				
Action/Comments					
Fence					
Inspector Comments: No new photo taken; this fence does not have a CVFPB Permit.

There is no permit for this fence and gate crossing levee crown roadway.

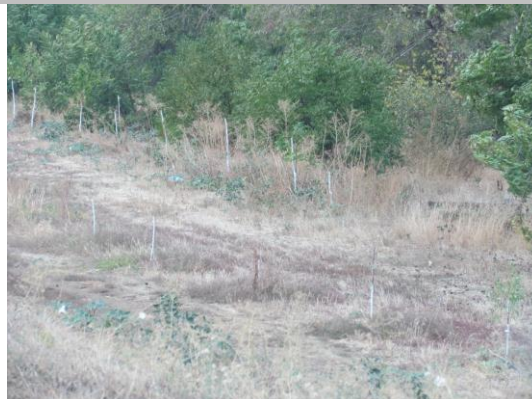
Photo 1 of 1 : FA_2014_ST0007_283_10_20141126_00010.jpg

LM Start	6.54	Rating **	U	Issue No.	10
LM End	6.67	Issue Type +	En	Location *	WS
Category	Earthen Levee			GPS Latitude/Longitude	
				Start	End
Item	Encroachments			38.517596 °	38.518361 °
				-121.771910 °	-121.774050 °
DWR ID	DWR_ST0007_02_s_ 2014_10				
Action/Comments					
Tree or limb Inspector Comments: There are 62 unauthorized walnut trees planted on the waterward ward berm, no permit. During the Spring inspection 4-15-2014 no new photo was taken of this issue.

Levee miles 6.54 to 6.67 unauthorized tree plantings on the waterward berm with no permit. These trees were planted in 2012.

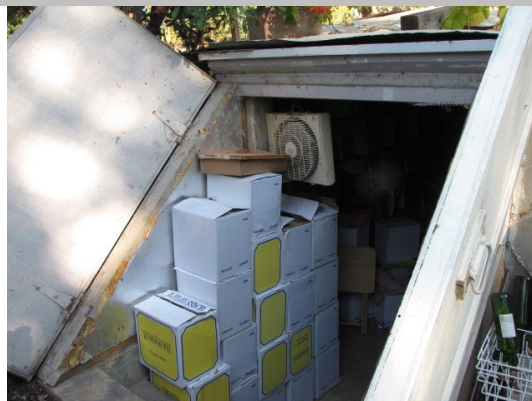
Photo 1 of 1 : FA_2014_ST0007_283_18_20141008_00002.jpg

Inspector Comments: Unit 2 Putah Creek approx. levee mile 6.79 the property owner has an underground wine cellar within the landward levee slope. We have no knowledge how long its been there. This site is under review in 2013. No new photo was taken 4-15-2014. Problem still being looked at by CVFPB.

Unauthorized wine cellar.

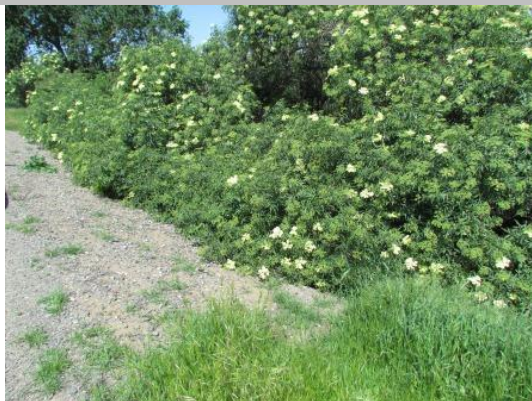
Photo 1 of 1 : FA_2014_ST0007_283_38_20141008_00006.jpg

LM Start	6.95	Rating **	M	Issue No.	38
LM End	7.06	Issue Type +	Ma	Location *	WS
Category	Earthen Levee			GPS Latitude/Longitude	
				Start	End
Item	Vegetation			38.520602 °	38.521467 °
				-121.778191 °	-121.779795 °
DWR ID	DWR_ST0007_02_s_2014_38				
Action/Comments					
Elderberries are blocking visibility and flood fight capability. Inspector Comments: These elderberries at this location need to be trimmed.

Looking downstream at elderberry trees blocking the view of the waterward slope and toe. Photo taken 4-15-2014.
